AI ID: 85638 **Inspector:** Shavaun Jenkins

Site Name: Merritt Properties LLC
Facility Address: 435 Ginn Lane, Pasadena, MD 21122
County: Anne Arundel County

Inspection Date: May 15, 2020 **Start Date/Time:** May 15, 2020, 11:00 AM
End Date /Time: May 15, 2020, 12:25 PM

Tidal Wetlands- Inspection Checklist

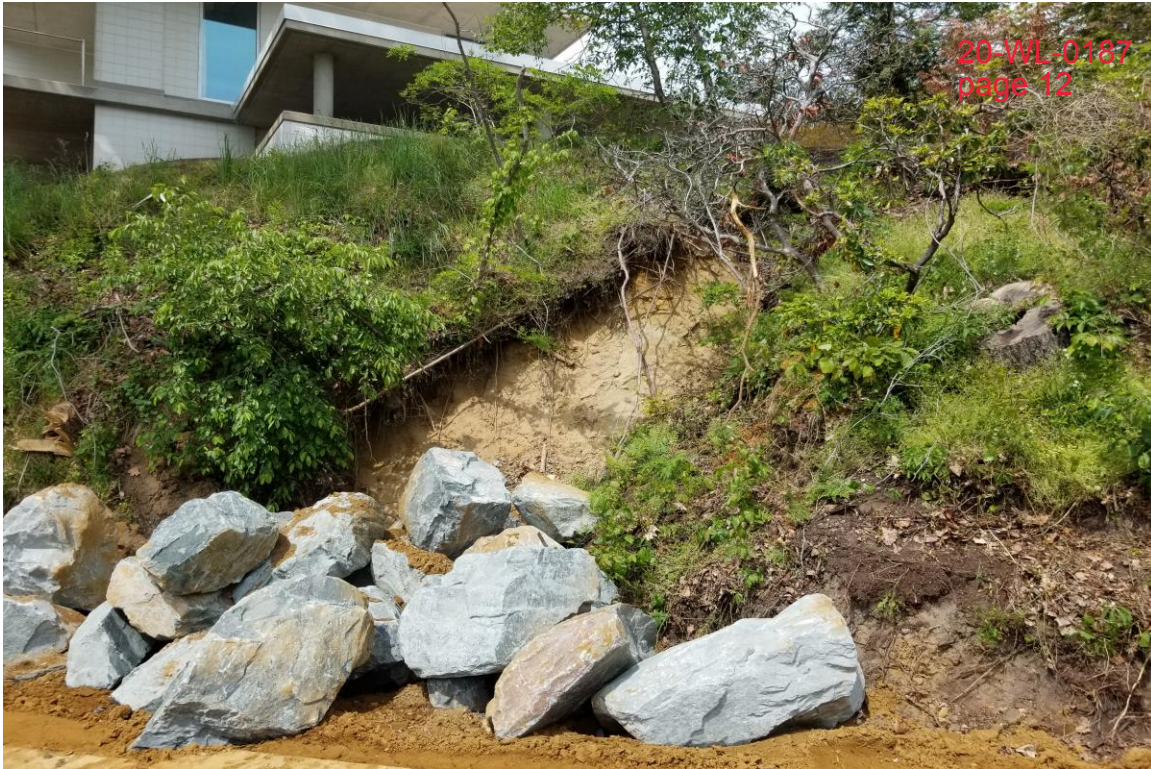
failure areas were observed and Mr. Swatko advised of the intent to use stone and fill to stabilize the slope failure areas.

Figure 1 Slope failure observed (facing W perimeter)

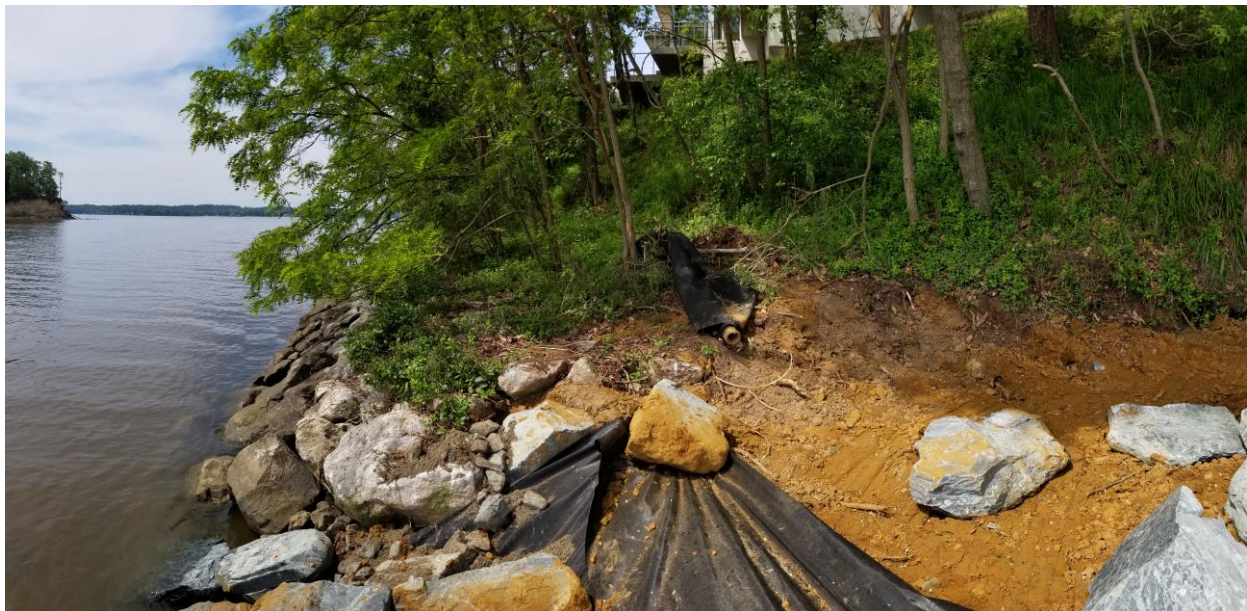
Figure 2 Panoramic view of the existing revetment connecting to the to be constructed revetment (facing S perimeter)

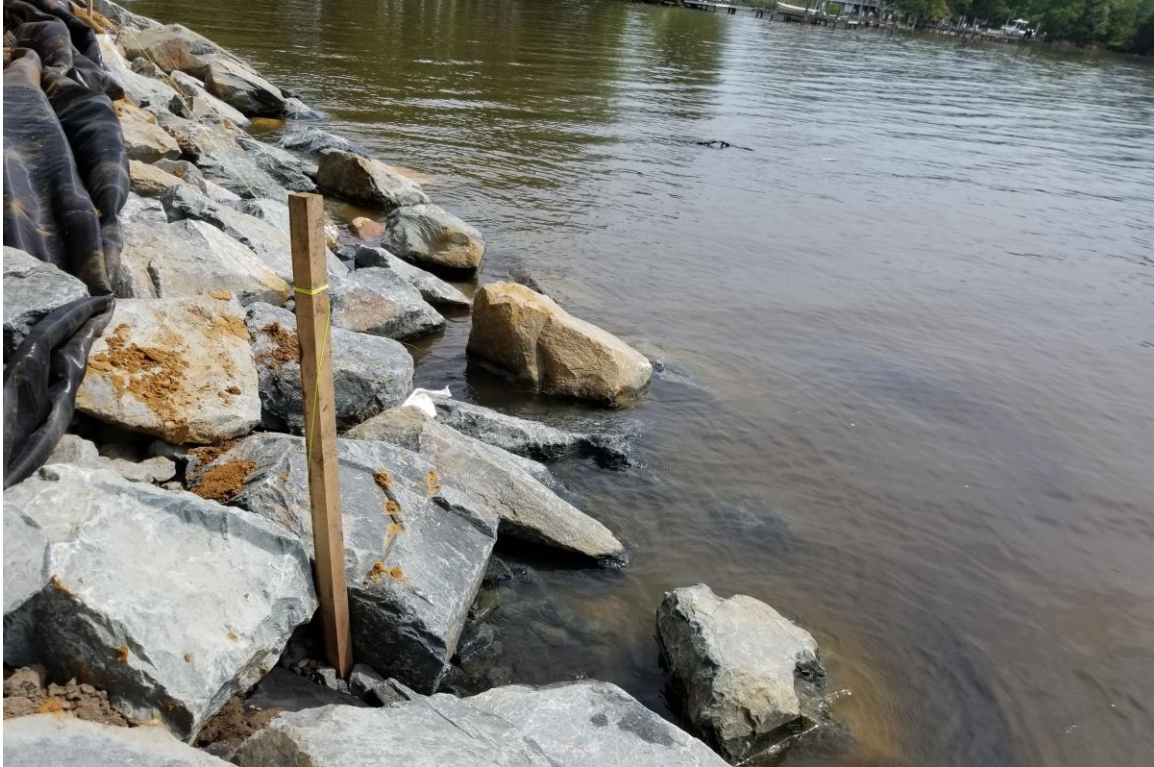
The site walk determined the installed fill material and stone revetment are exceeding the authorized maximum 15 feet channelward of the mean high water line. The timber mats, used in some areas of the access road, are 14 feet wide. Along the southernmost to central portion of the site the access road ranged in width between about 14 to 18 feet. From north of the jut of the peninsula to the end of the project was approximately 147 feet long. Some of the rip rap was observed beyond the stone revetment installed. Both contacts assured the observed rip rap would be reclaimed and returned to the stone revetment. **Ensure the rip rap is does not remain in tidal wetlands.** Both parties advised the marine contractor installed a double boulder layer for the stone revetment compared to the existing stone revetment which is a single layer. The northernmost perimeter of the project identified on the license as “no impact to state tidal wetlands” has also been expanded. Accurate measurements of this area could be not obtained as I was uncertain of the location of the original upland area.

Figure 3 Rip rap stone observed beyond installed stone revetment

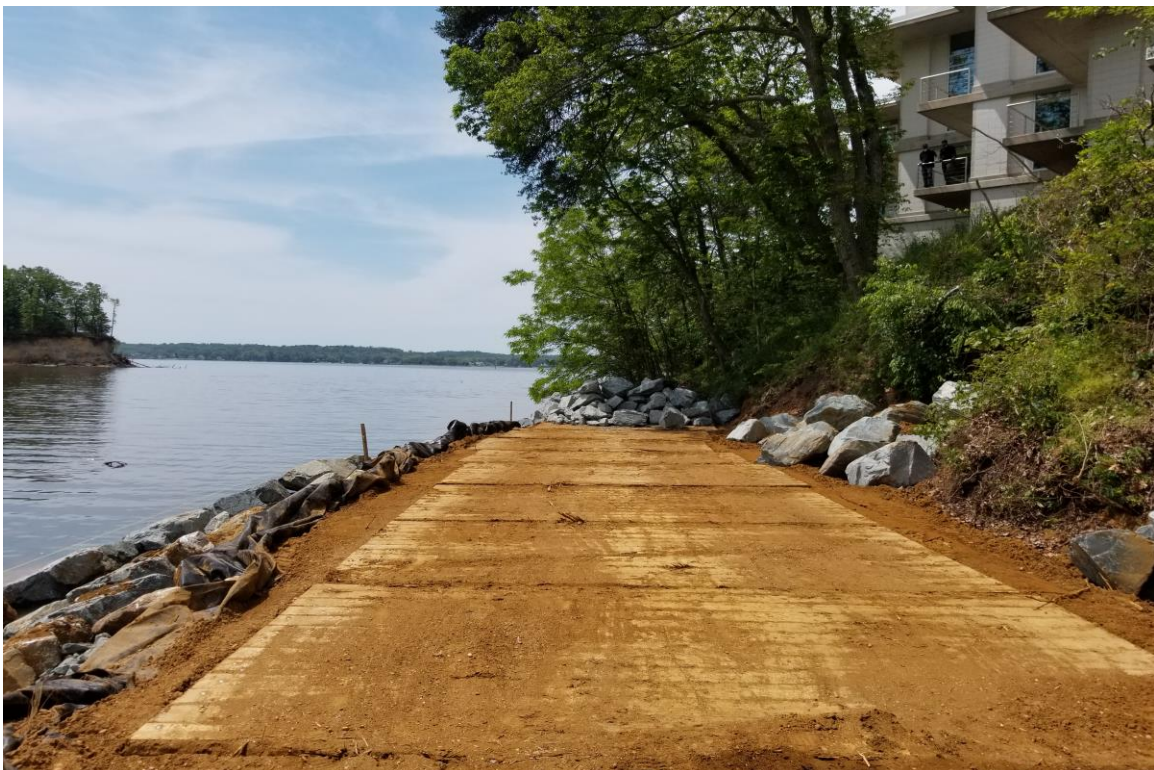
Figure 4 End of access road with rip rap stock pile (facing S perimeter)

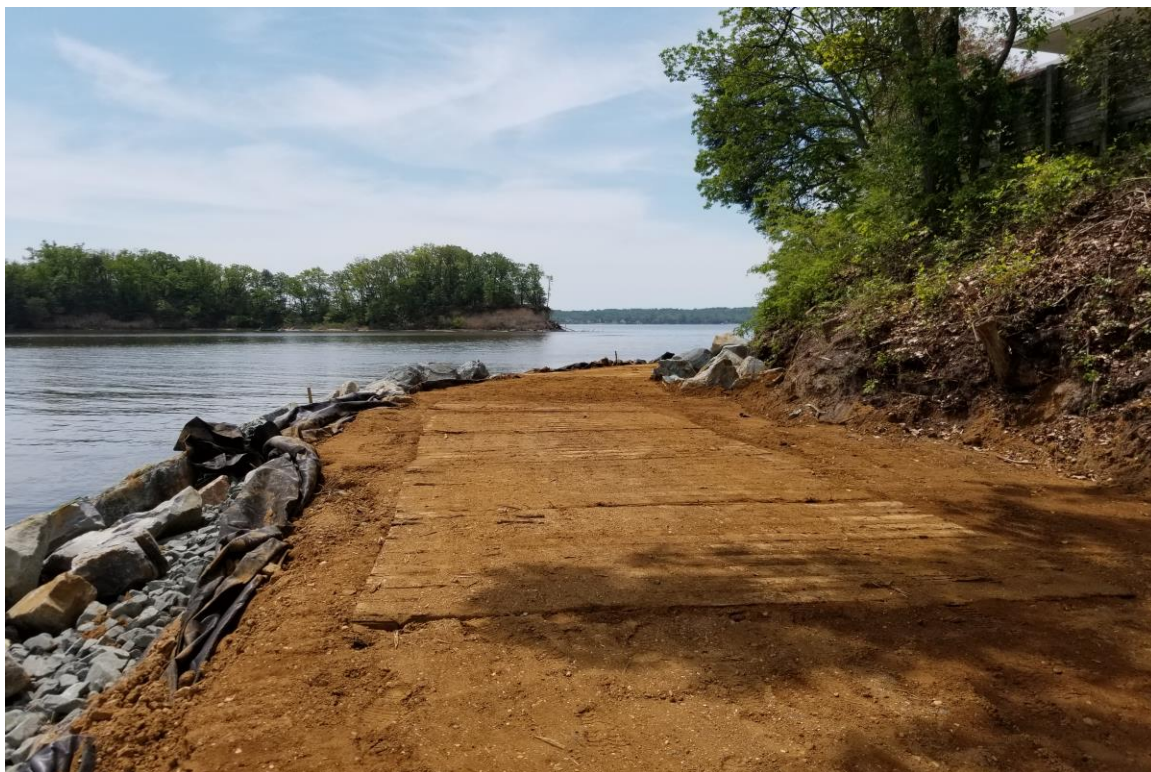
Figure 5 Access road N of the jut in peninsula (facing S perimeter)

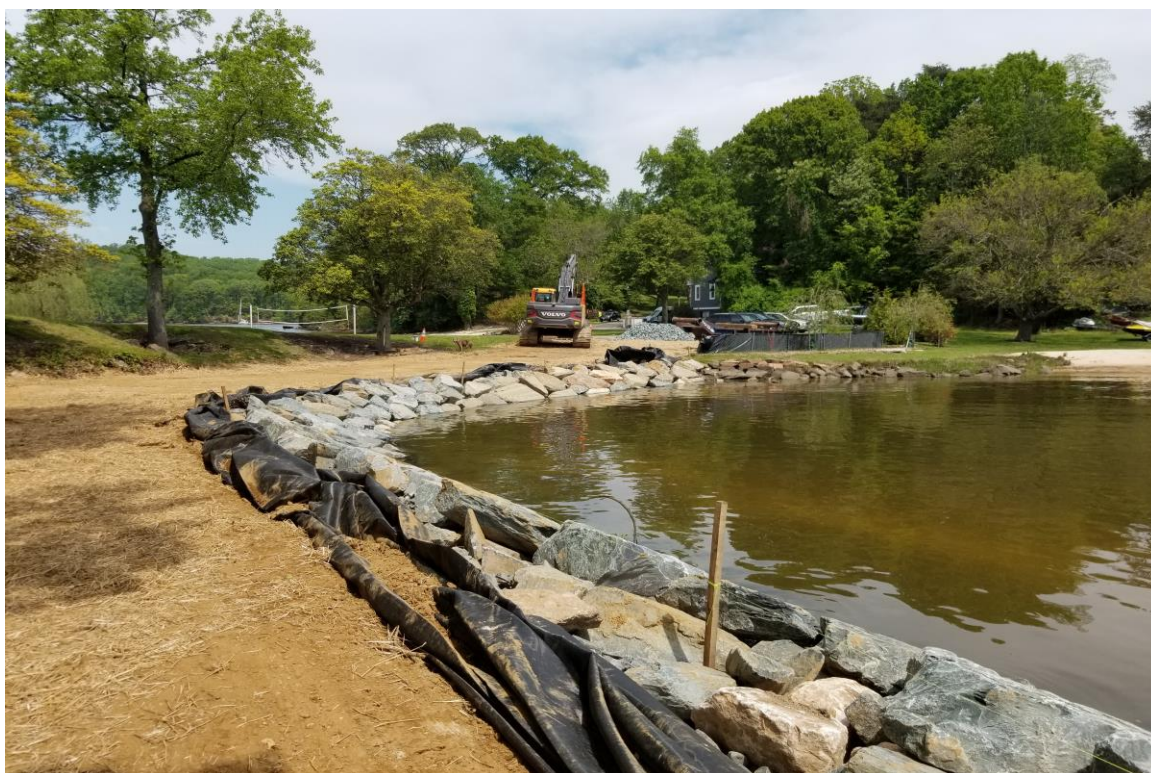
Figure 6 Beginning of access road from the mainland (facing N perimeter)

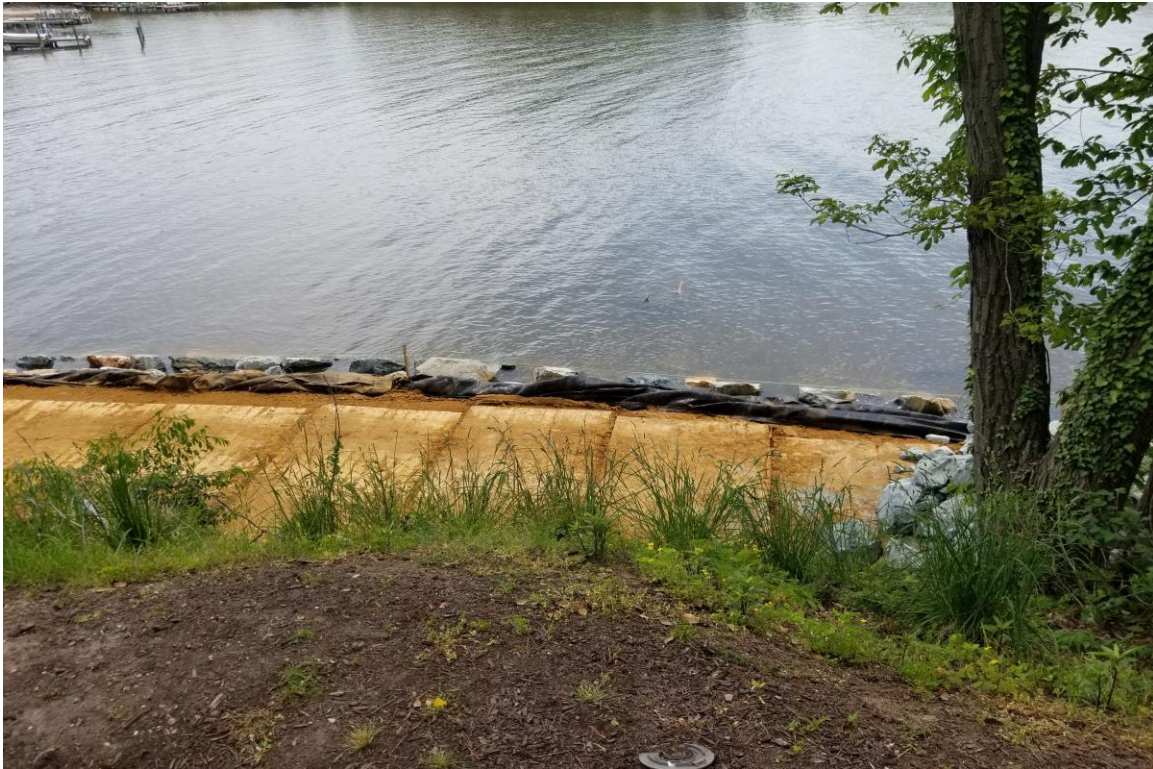
1. Installed is an incomplete stone revetment with an undetermined amount of fill material (used as an access road) exceeding the authorized maximum 15 feet channelward of the mean high-water line. For the southernmost to central perimeter of the project, the access road and stone revetment measurement ranges from approximately 21 to 30 feet channelward (at low tide) into Broad Creek. **Immediately remove excess fill and stone to bring site in compliance with the 20-WL-0141EX license or proceed with contacting Tidal Wetlands Plan Reviewer Matthew Wallach at (410) 537-3527 or Matthew.Wallach@maryland.gov to determine if a modification of the license would be authorized.**

Figure 7 Access road and stone revetment observed from the elevation of the home (facing the E perimeter)

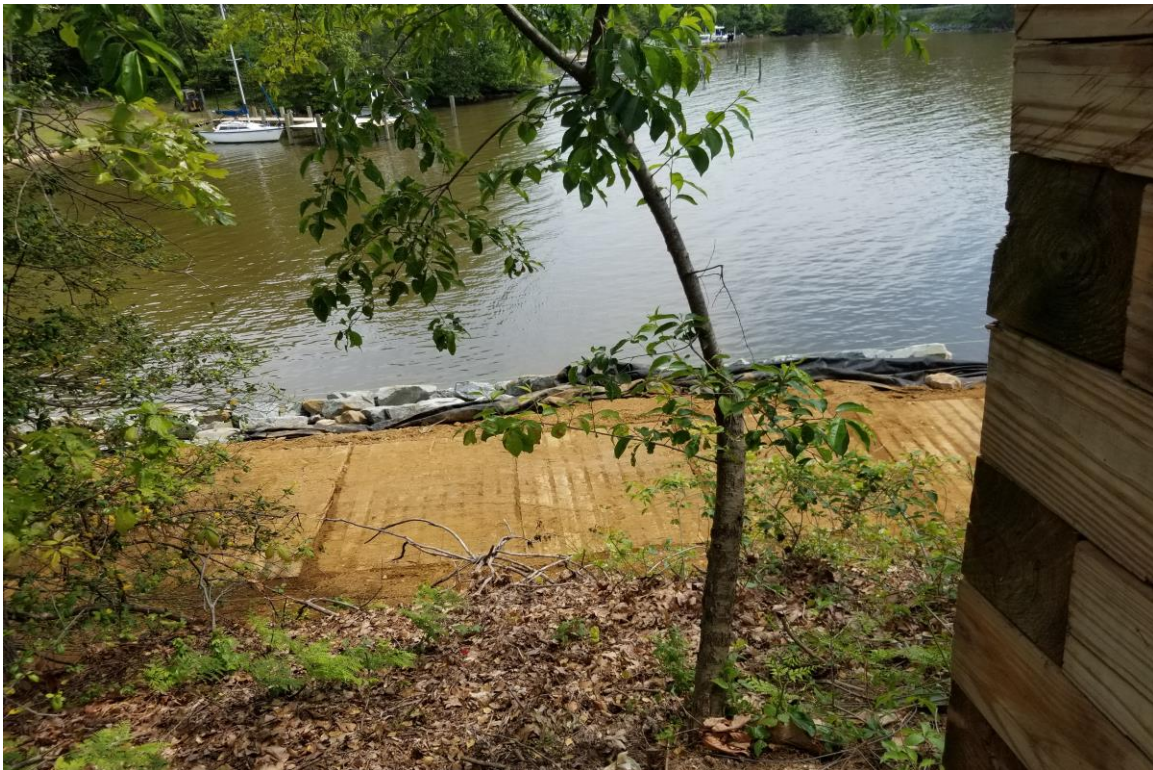
Figure 8 Access road and stone revetment observed from the N perimeter of the utility structure (facing E perimeter)

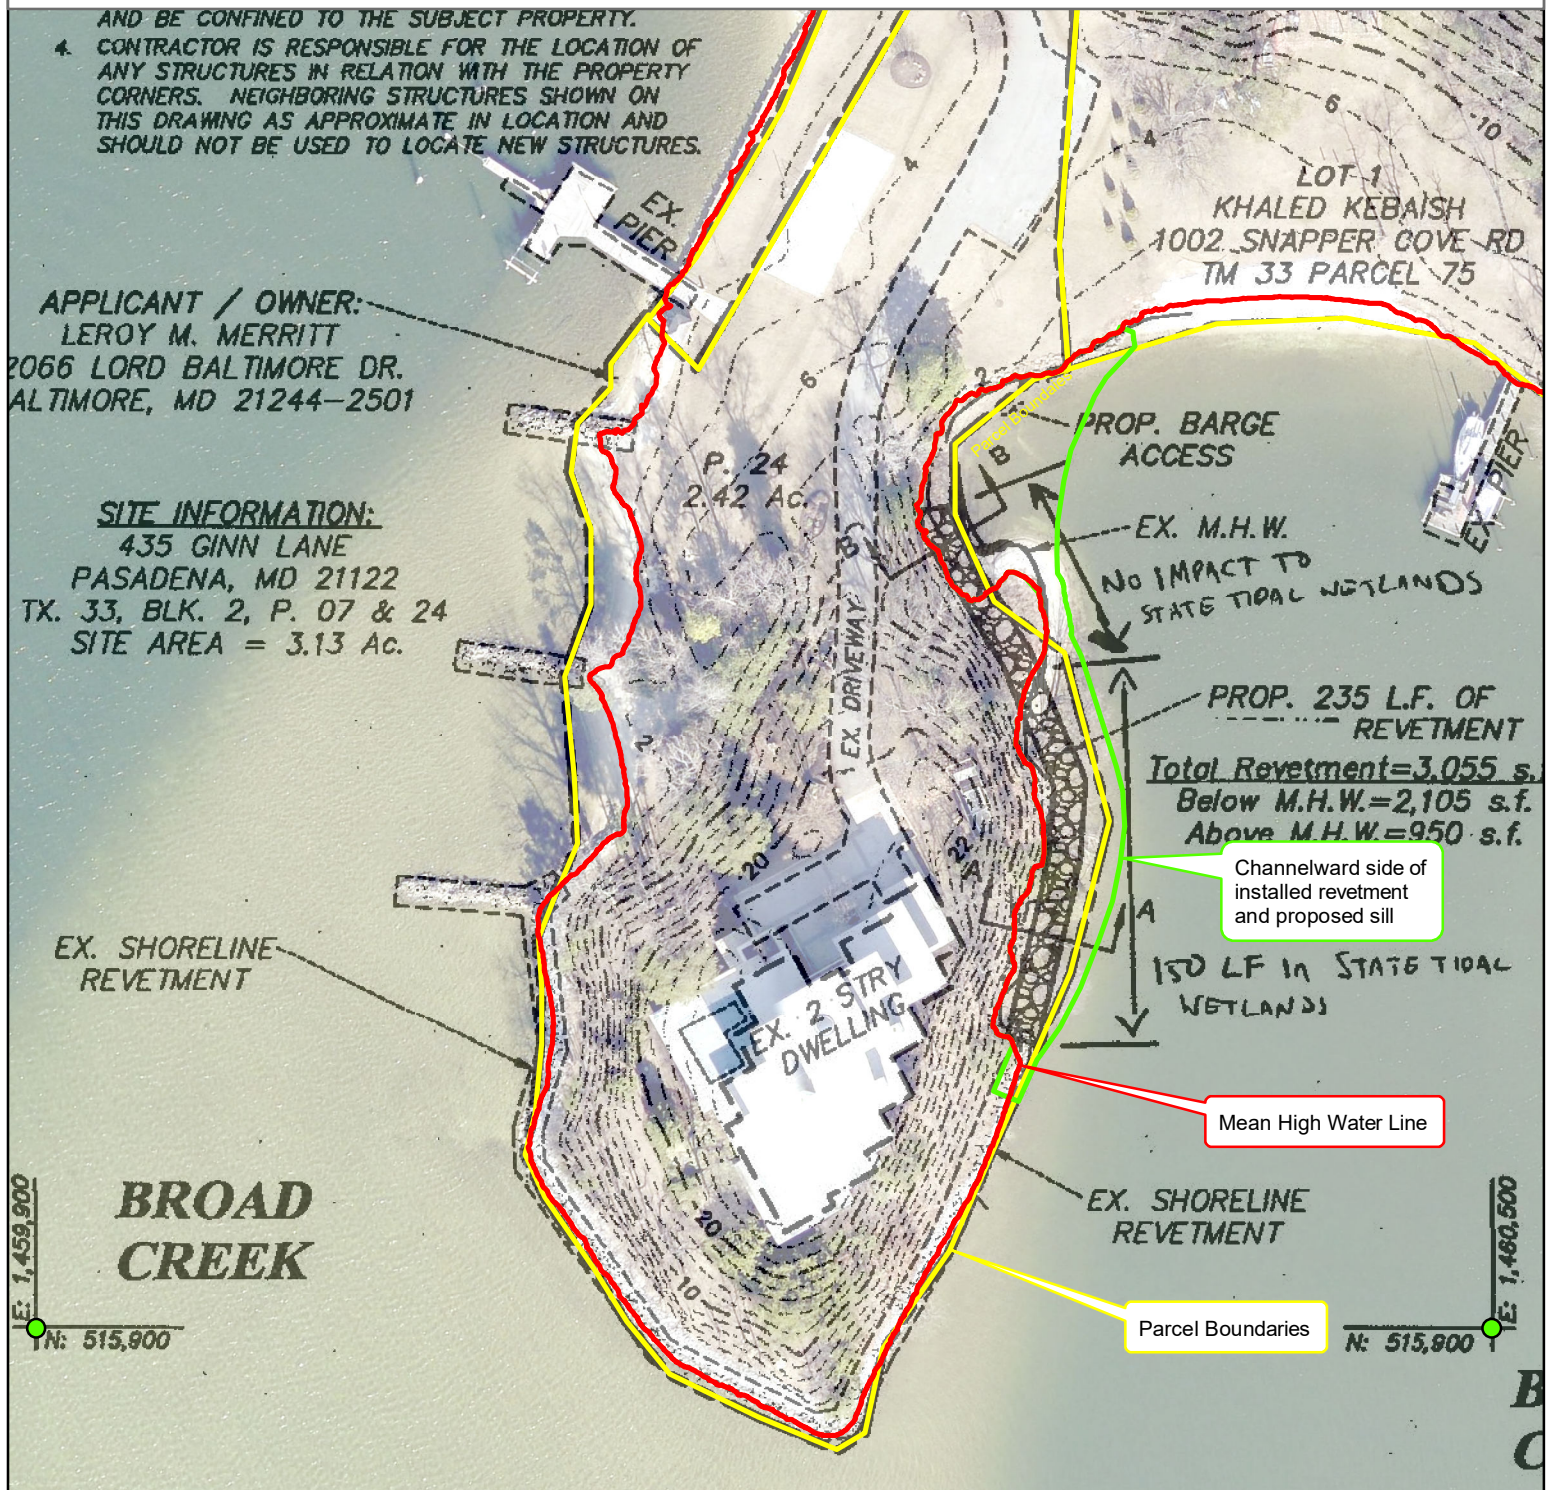
Tidal Wetlands Revetment Placement Review - Results Map

The site map was extracted from the permit application in a PDF format. The site map was not spatially referenced. The map contained reference markers (noted with green points) that were identified with coordinates in MD 1983 Stateplane Feet. The coordinates were used to spatially position the site map using the Georeference Tool set in ARCMAP. To confirm the results of the spatial referencing, the Anne Arundel County/MD SDAT parcel boundaries data layer was added. The parcel boundaries on the site map are consistent with the parcel boundaries from SDAT. Also shown for reference are the derived MHWL and the Channelward side of the installed revetment and the proposed sill.

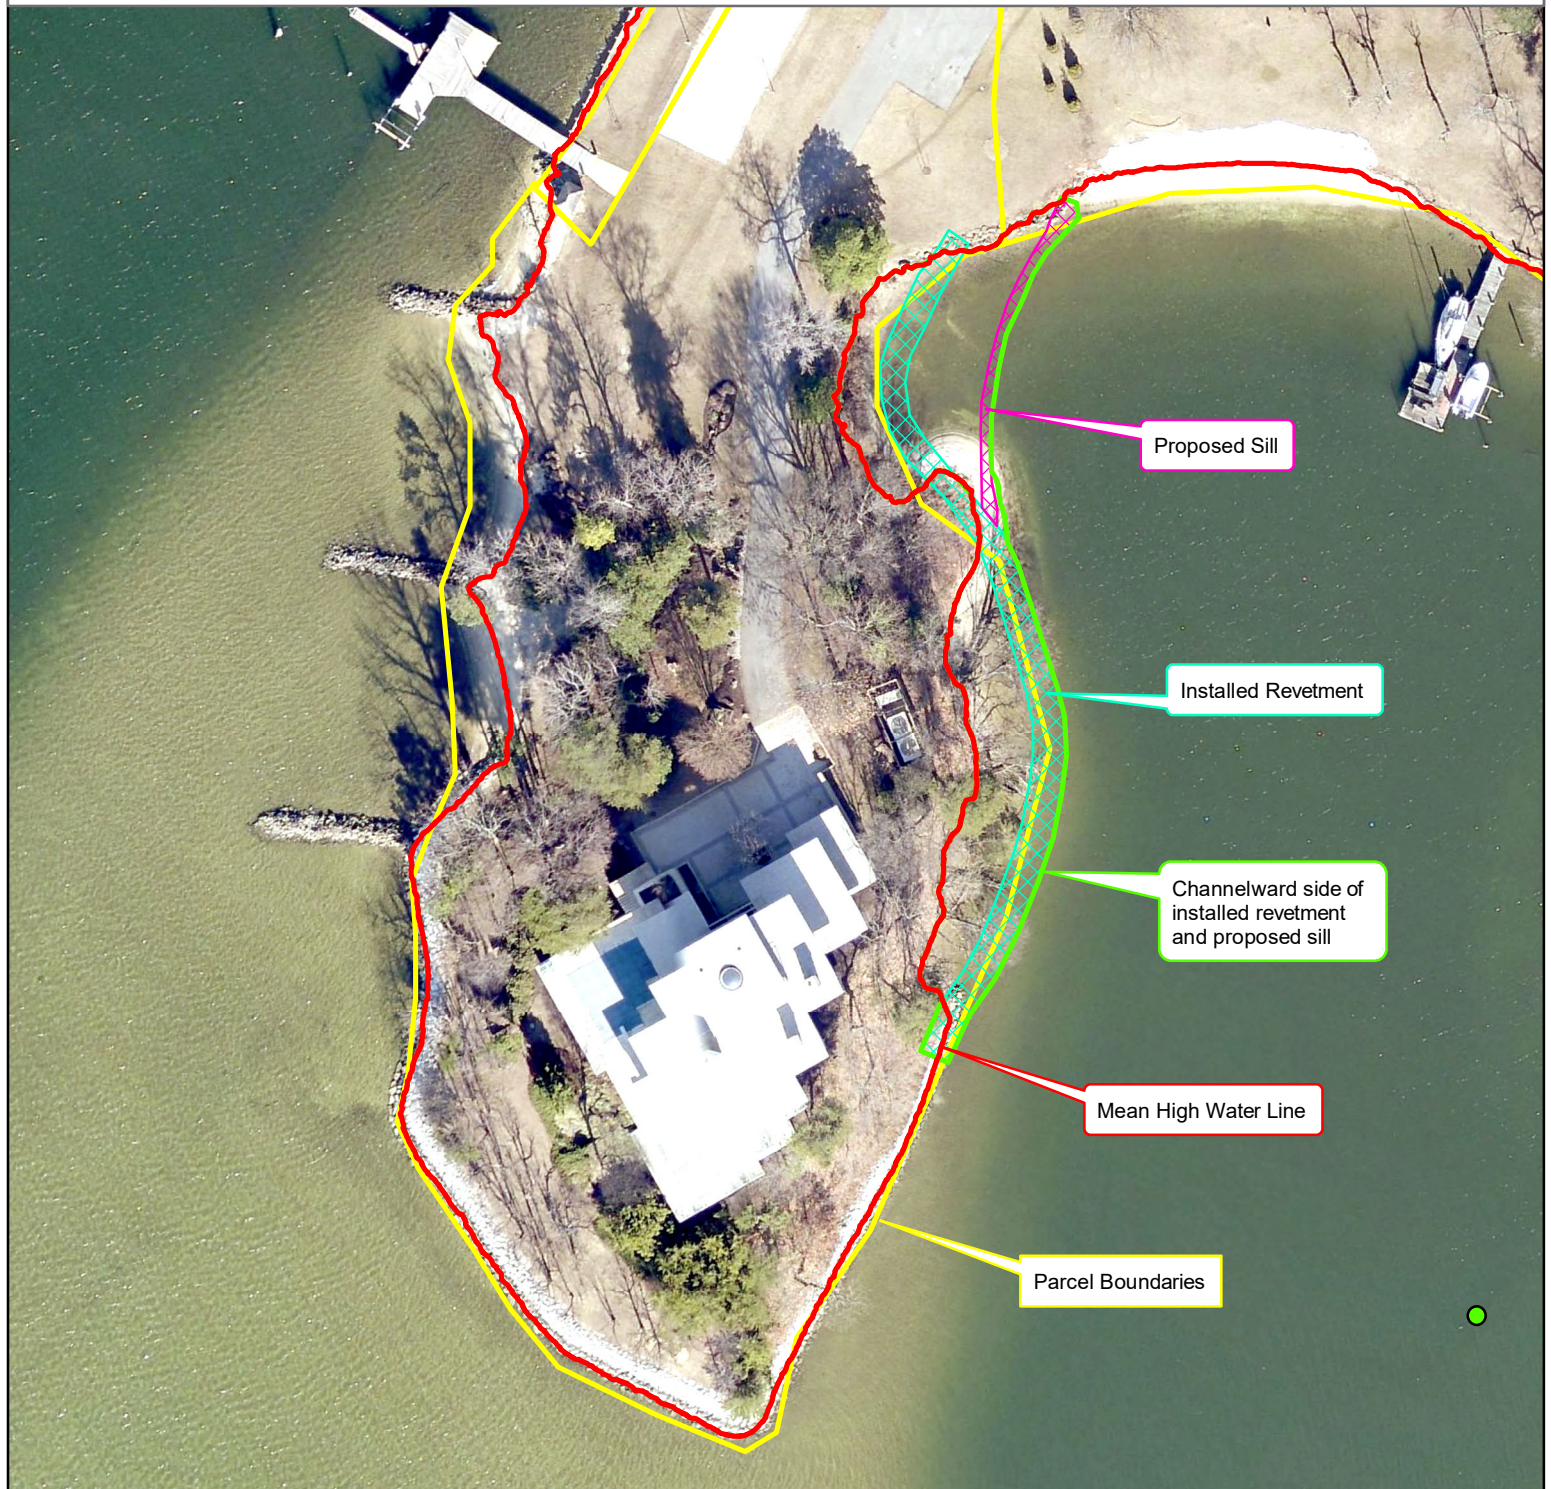
Tidal Wetlands Revetment Placement Review - Drone Image

The drone image map was received in a TIFF format and not spatially referenced. The Georeference Tool set in ARCMAP was used to apply a spatial reference to the image. To perform the georeference, matching features on both images were noted and selected. ARCMAP uses the selected features to rotate and shift the drone image into position on top of the 2017 imagery. The parcel boundaries were retained to show their location in relationship to the drone image.
